# FLORIDA A & M UNIVERSITY

## JACKSON DAVIS HALL

FACILITY CONDITION ASSESSMENT

INSPECTION DATE: MAY 16, 2012

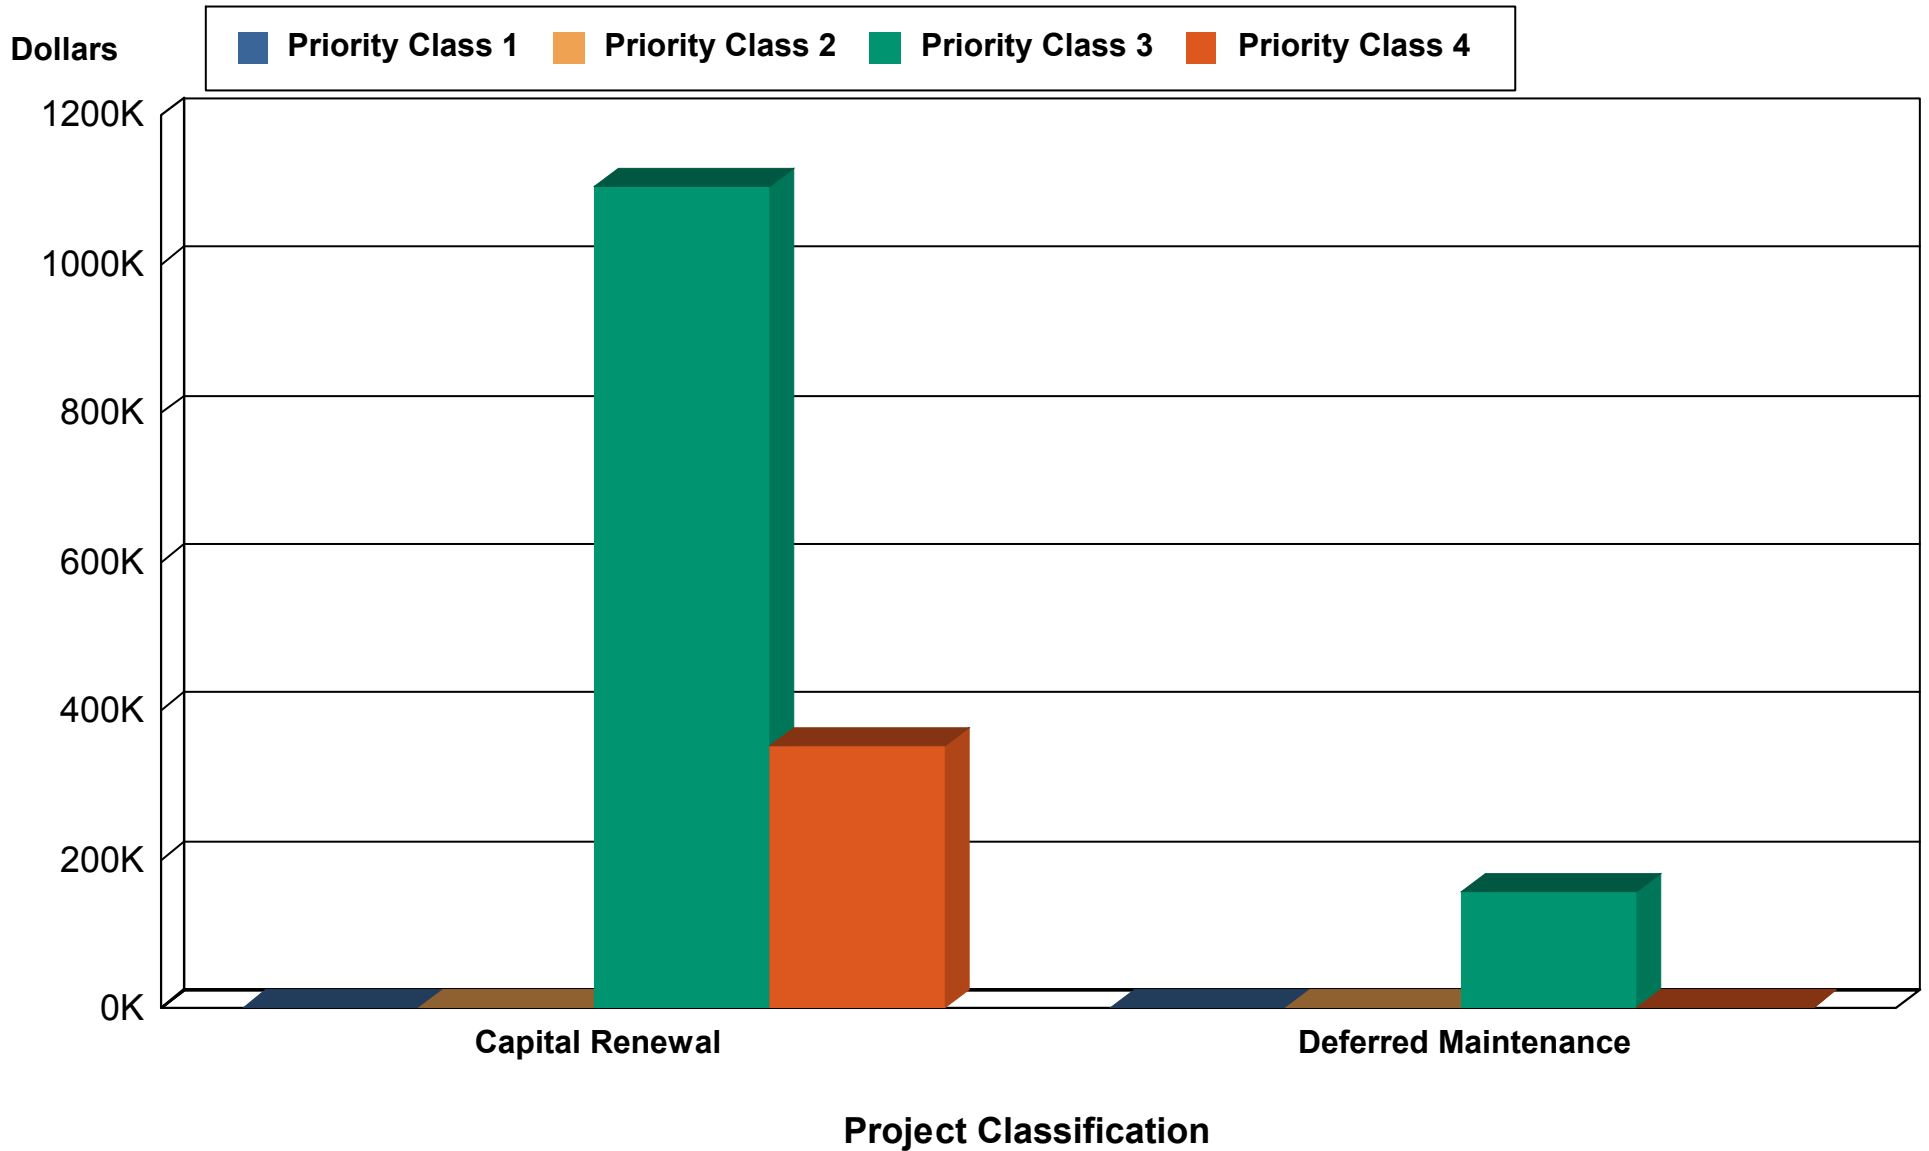
## Project Class by Priority Class

0002 : JACKSON DAVIS HALL

<b>Cat. Code</b>	<b>Project Number</b>	<b>Pri Cls</b>	<b>Pri Seq</b>	<b>Project Title</b>	<b>Construction Cost</b>	<b>Professional Fee</b>	<b>Total Cost</b>
FS2A	0002FS01	3	1	FIRE ALARM SYSTEM REPLACEMENT	45,199	7,232	52,431
FS3A	0002FS02	3	2	REPLACE SPRINKLER HEADS	6,933	1,109	8,043
ES5A	0002ES02	3	3	EXTERIOR DOOR REPLACEMENT	16,859	2,697	19,557
ES2B	0002ES01	3	4	EXTERIOR REPAIRS	14,860	2,378	17,237
HV3A	0002HV01	3	5	HVAC SYSTEM REPLACEMENT	475,003	76,001	551,004
EL3B	0002EL03	3	6	ELECTRICAL SYSTEM REPAIRS	13,095	2,095	15,190
EL4B	0002EL02	3	7	INTERIOR LIGHTING UPGRADE	122,130	19,541	141,670
EL2A	0002EL01	3	8	REPLACE 120/208 VOLT SWITCHGEAR	24,279	3,885	28,164
IS1A	0002IS01	3	9	REFINISH FLOORING	132,677	21,228	153,906
IS2B	0002IS02	3	10	REFINISH WALLS	31,411	5,026	36,437
IS3B	0002IS03	3	11	REFINISH CEILINGS	28,066	4,491	32,557
SI4A	0002SI01	3	12	SITE PAVING UPGRADES	6,697	1,071	7,768
VT7A	0002VT01	3	13	COMPREHENSIVE HYDRAULIC ELEVATOR MODERNIZATION	170,838	27,334	198,172
