# FLORIDA A & M UNIVERSITY

## OLD DRS 63

FACILITY CONDITION ASSESSMENT

INSPECTION DATE: MAY 14, 2012

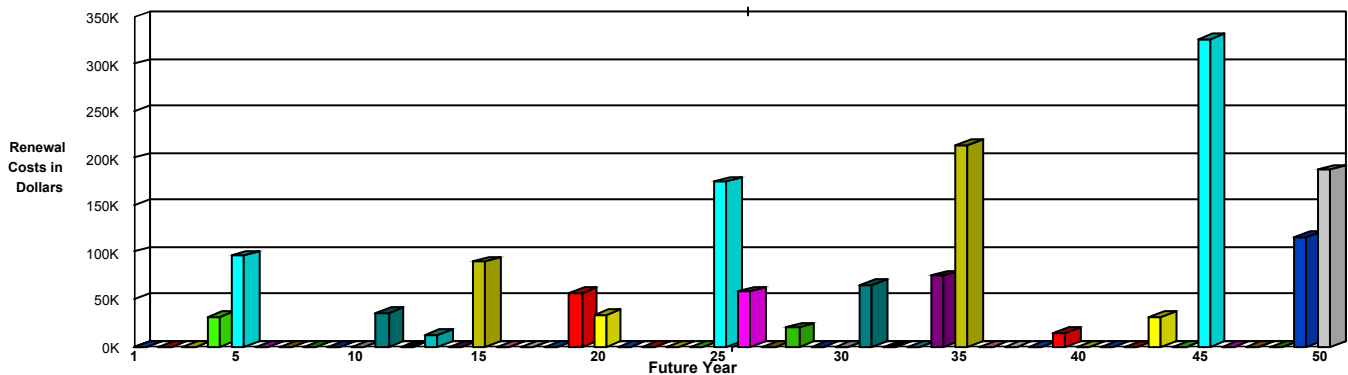
### Life Cycle Model Expenditure Projections

**Average Annual Renewal Cost per SqFt**      **\$4.55**

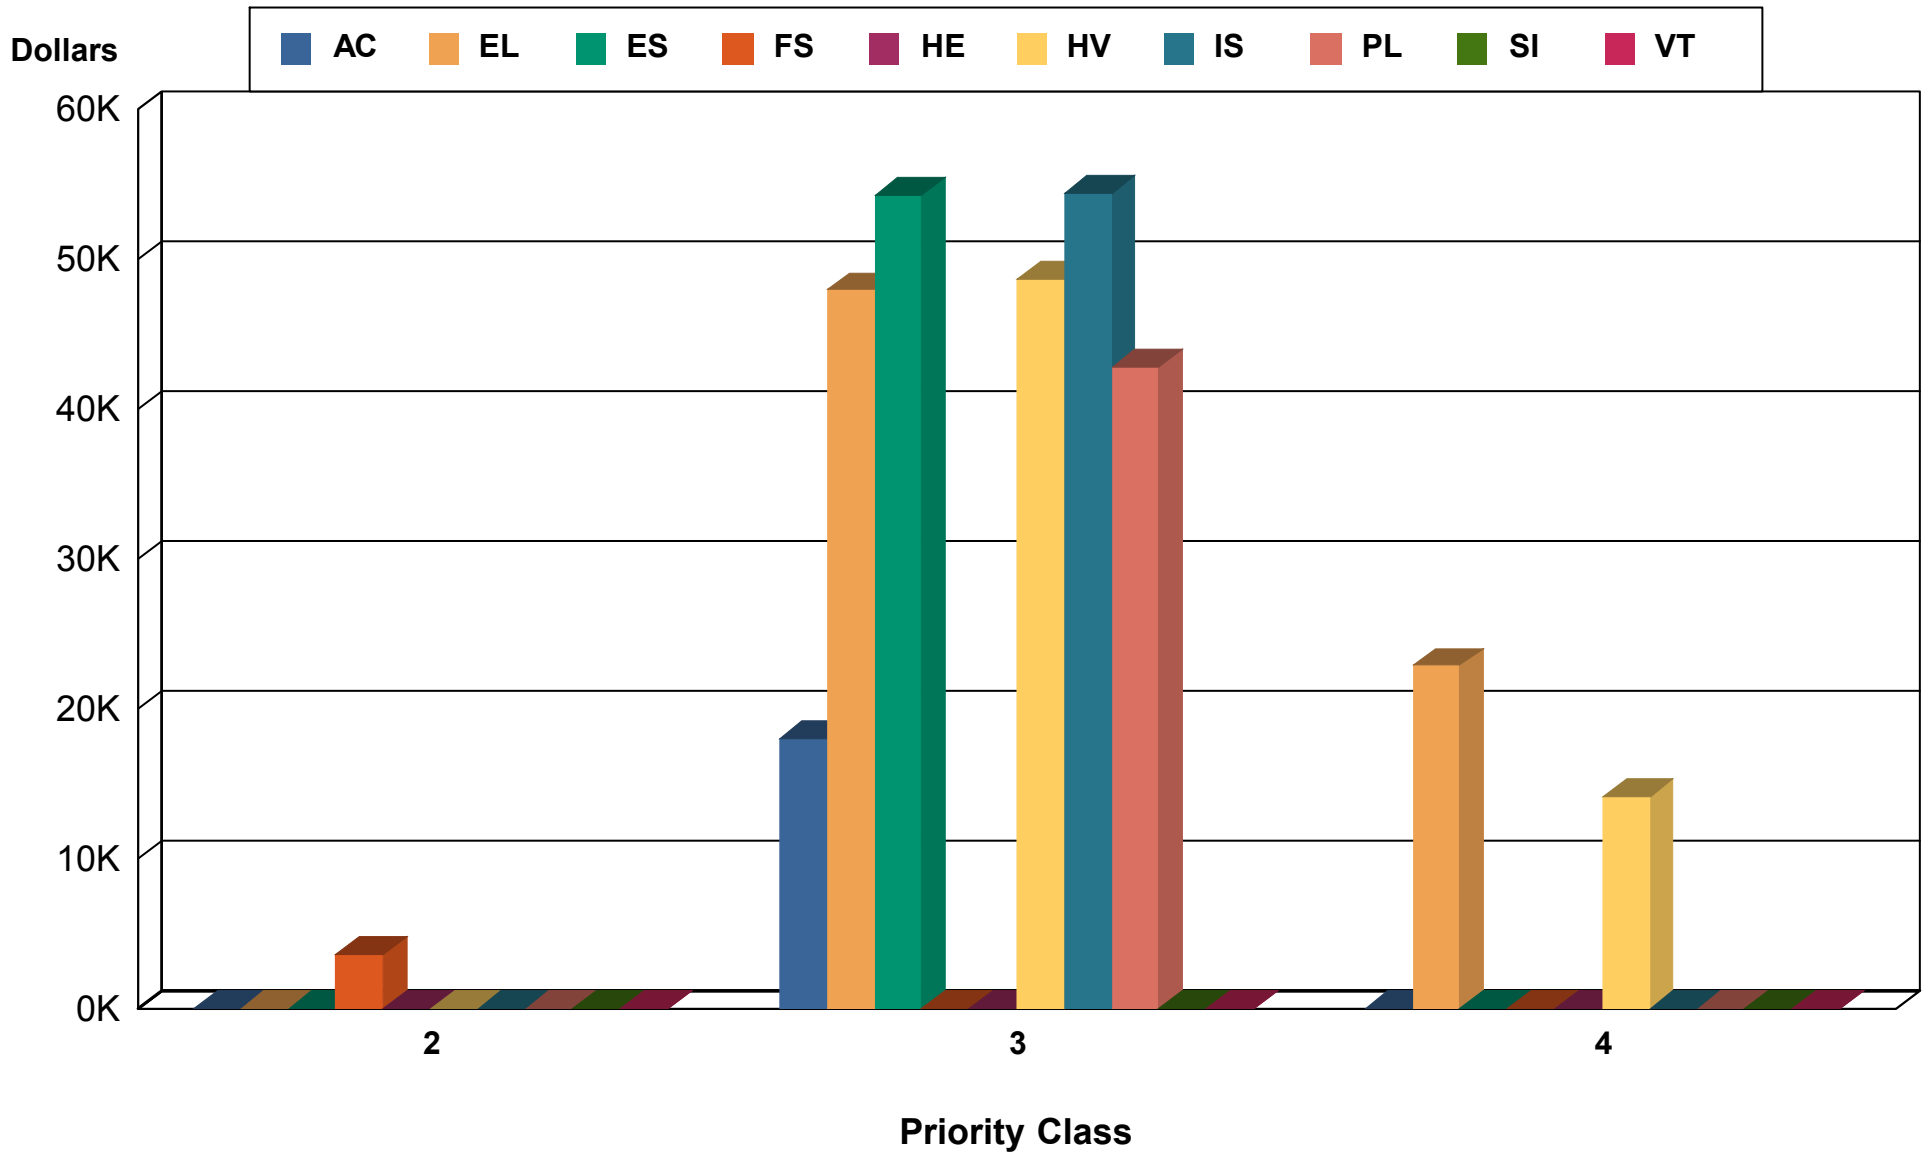
## System Code by Priority Class

0063 : OLD DRS 63

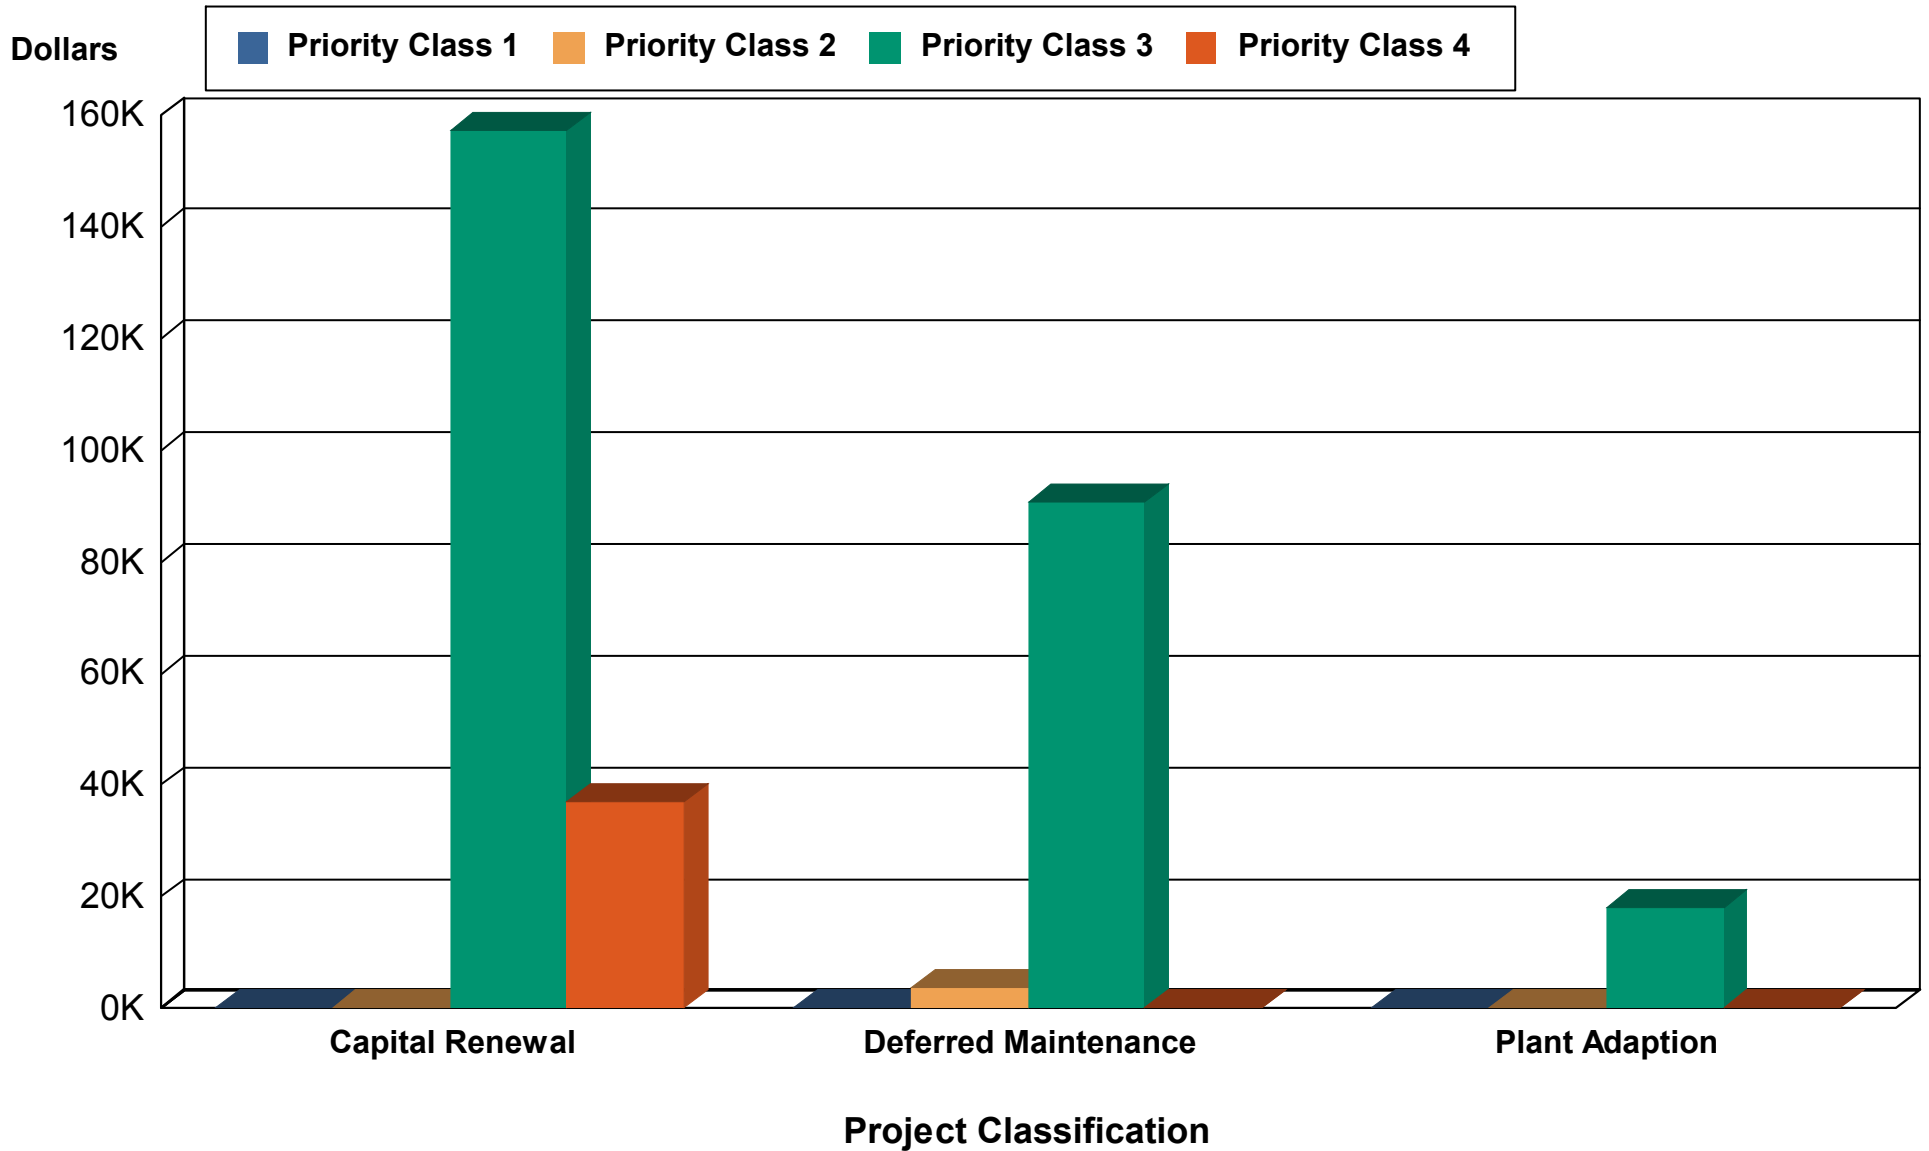
## Project Class by Priority Class

0063 : OLD DRS 63

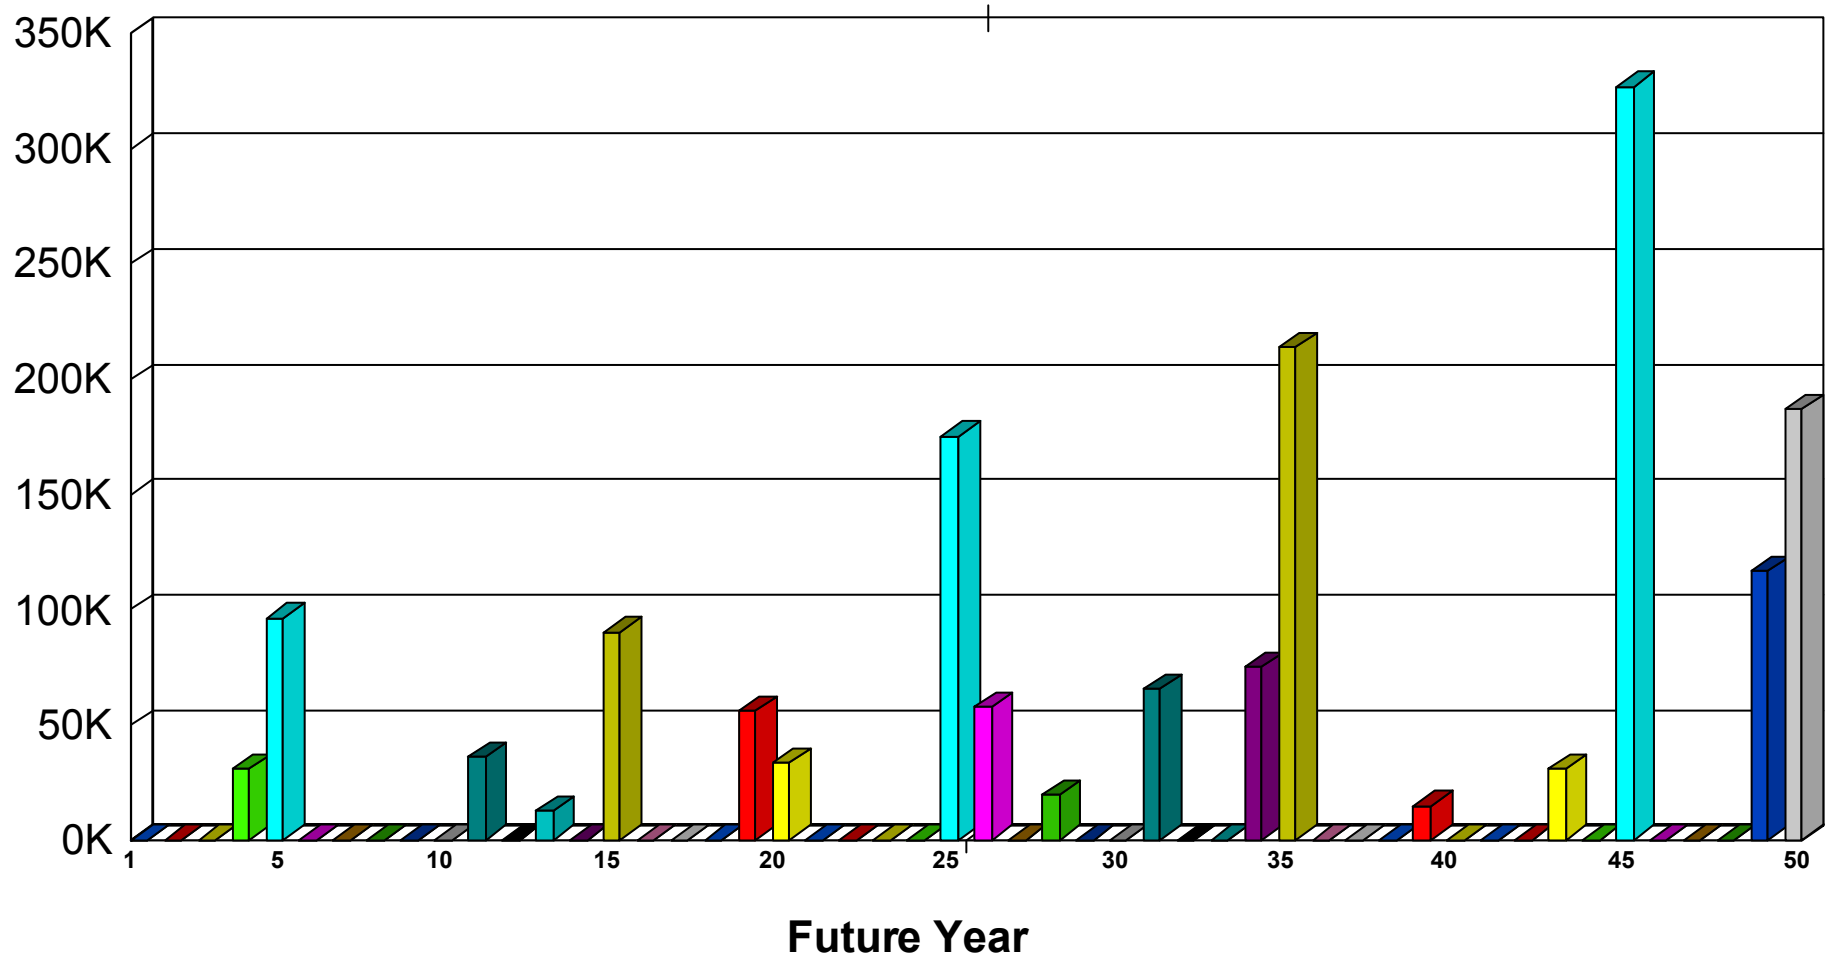
# Life Cycle Model Expenditure Projections

0063 : OLD DRS 63

Average Annual Renewal Cost per SqFt **\$4.55**
